ARSEE ENGINEERS, INC.

CLIENT ORIENTED — BY DESIGN

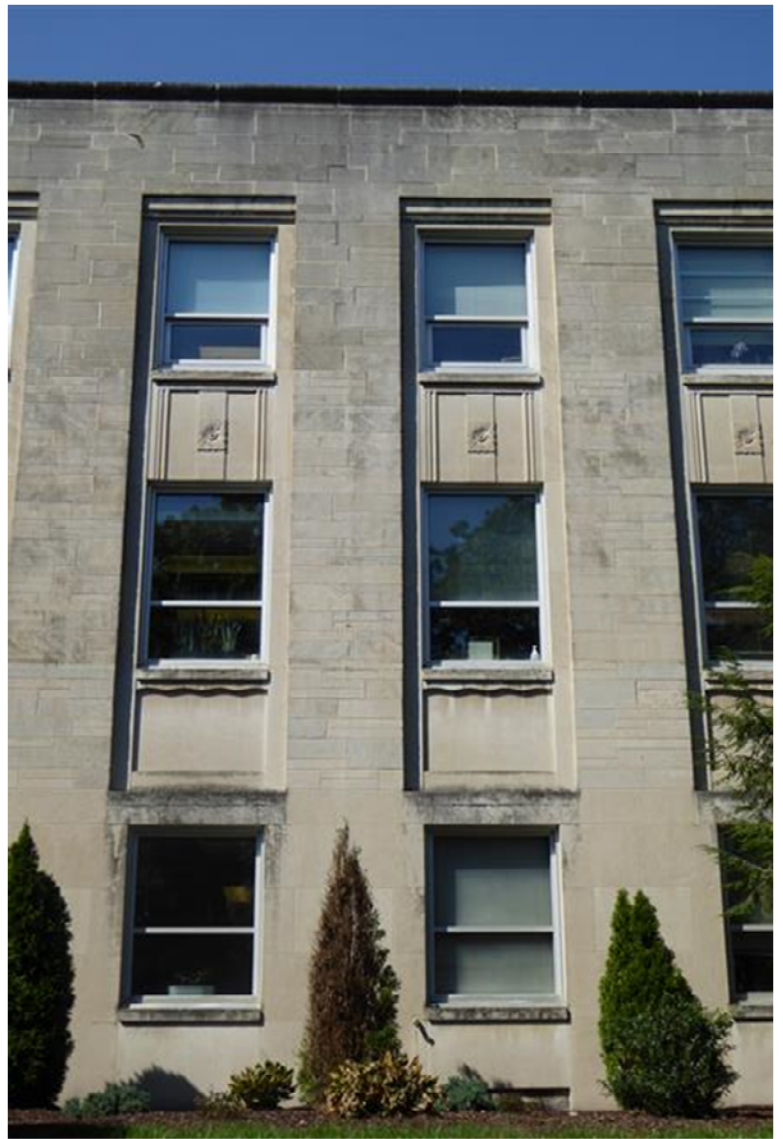
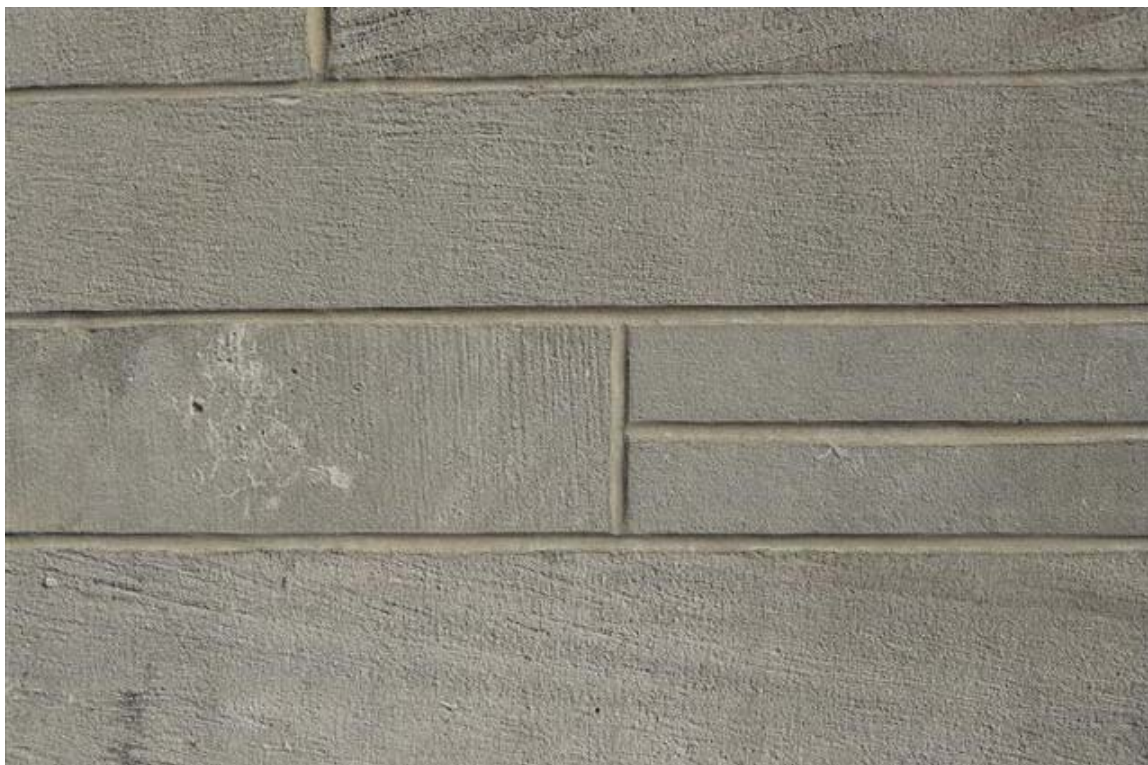
The façade is a combination of random ashlar and cut limestone. The stone itself is holding up well.

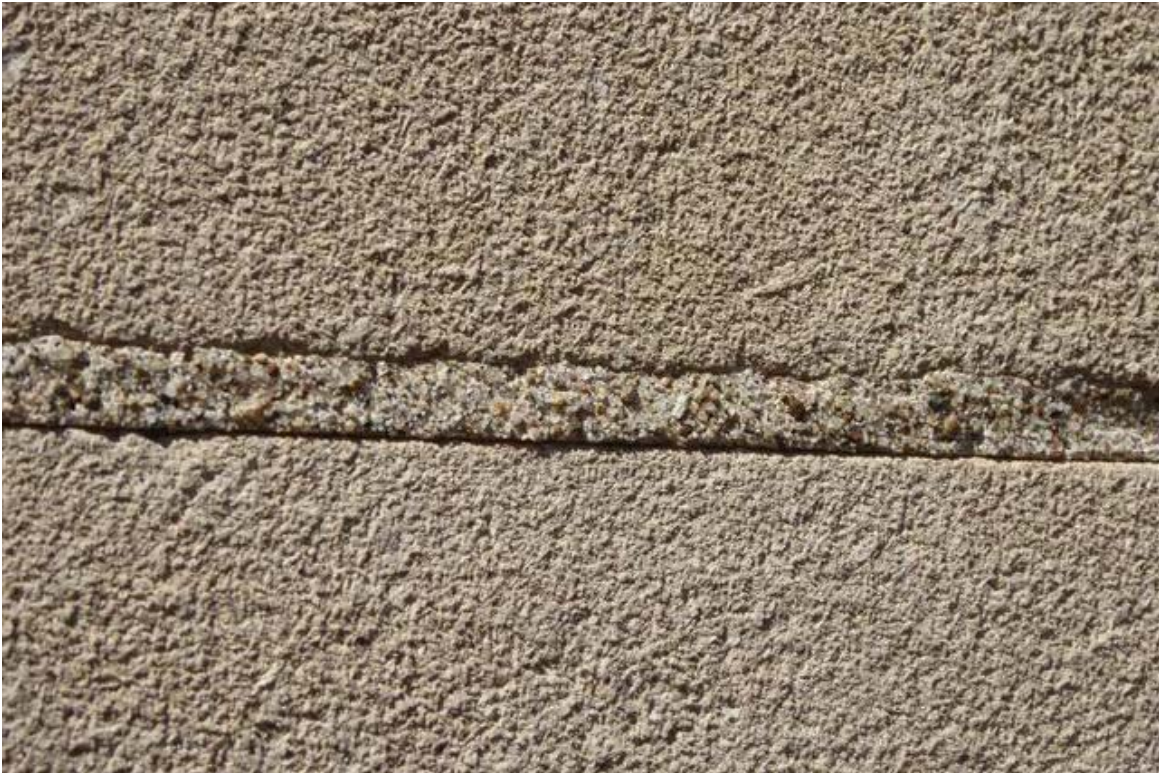
Photo 25 A few of the joints were struck flush and are more prone to moisture infiltration.

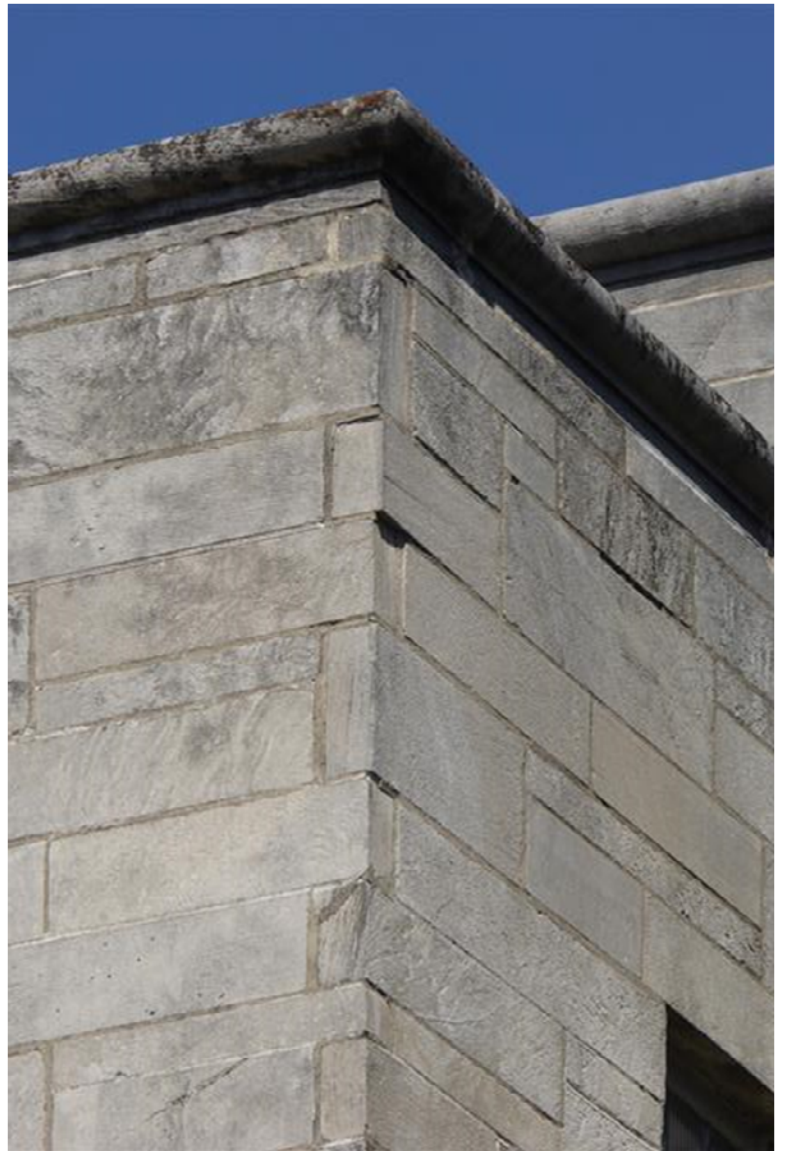
Joints near the top of the wall are wet most often. These need to be repointed.

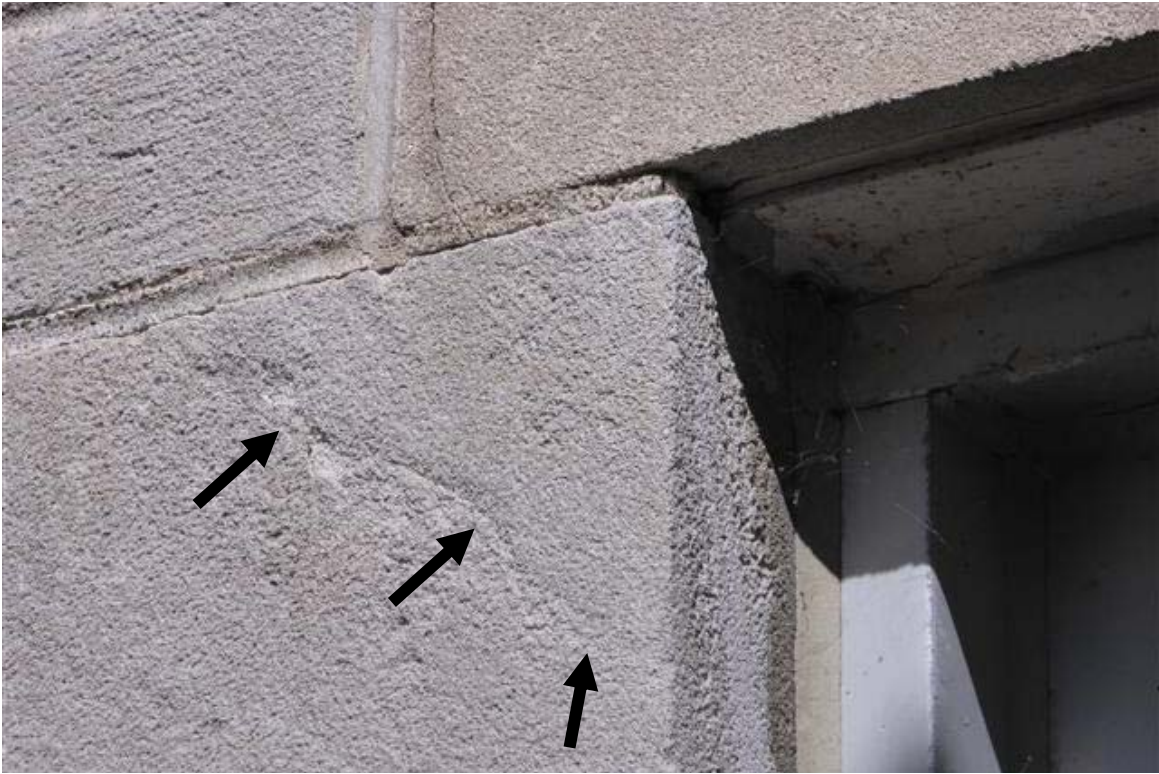
Photo 31 A cementitious patch was installed at a previous spall.

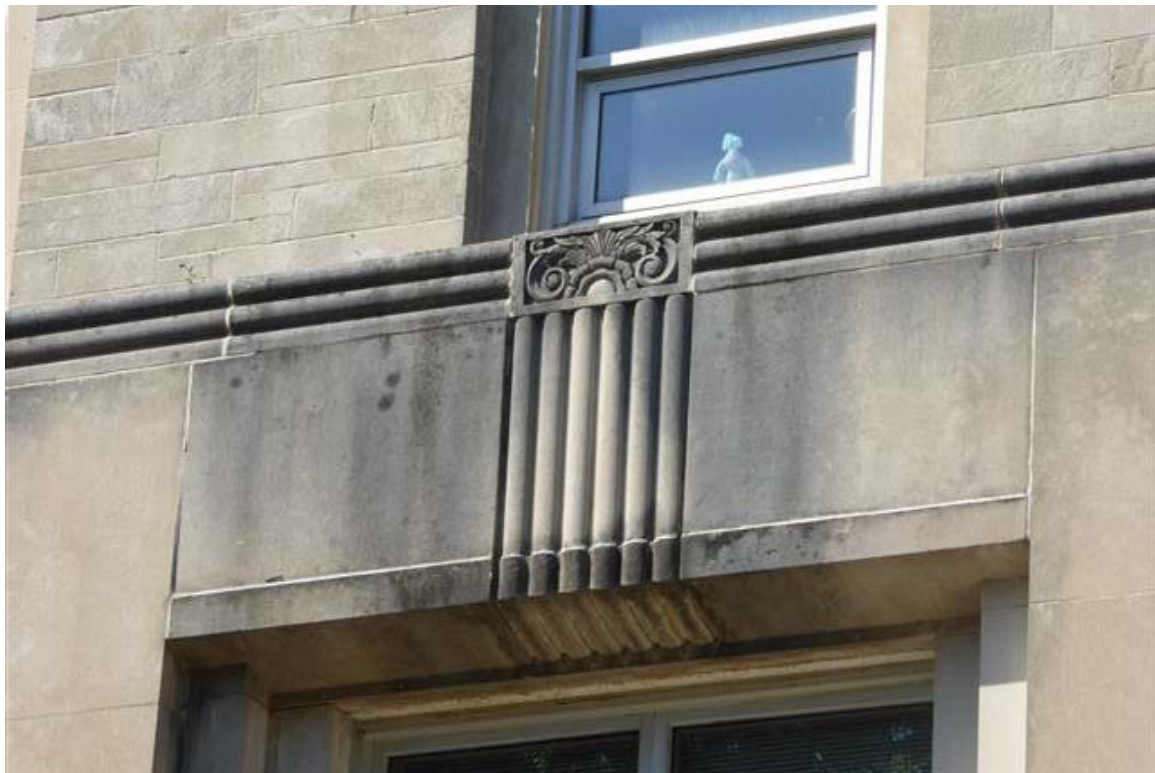
Photo 32 Organic material grows on the face of the protrusion over the east entrance.

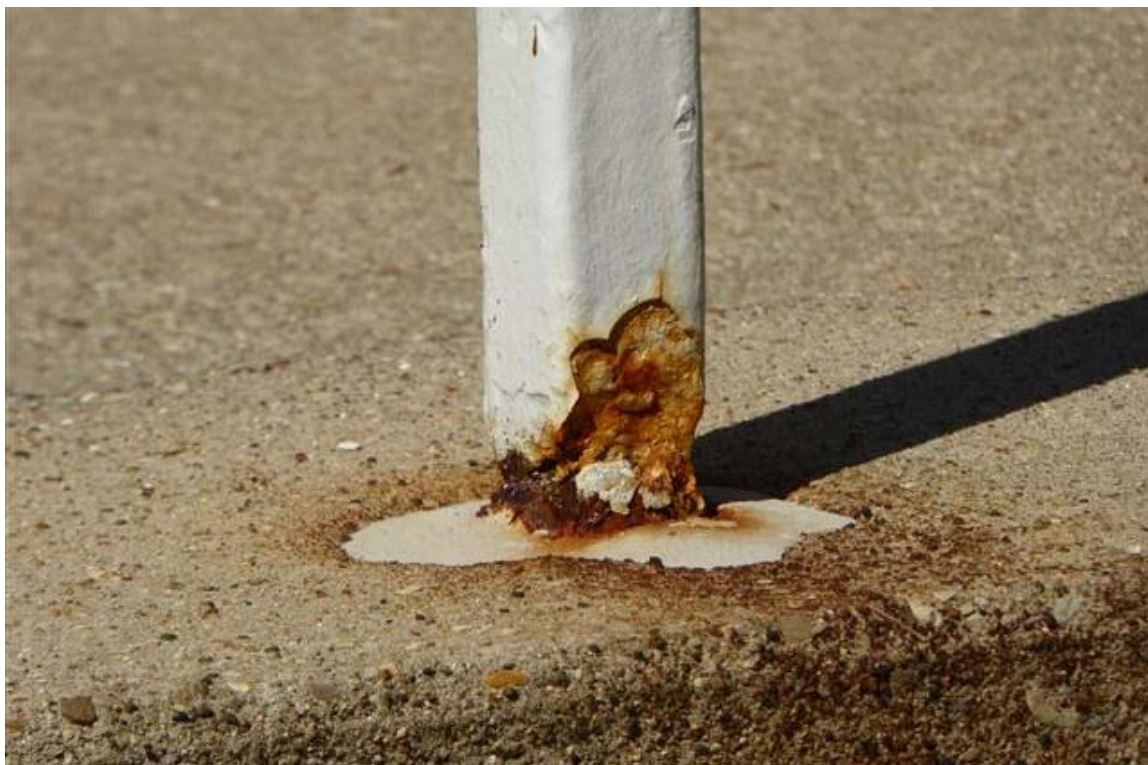
The hand railings do not meet current code requirements...

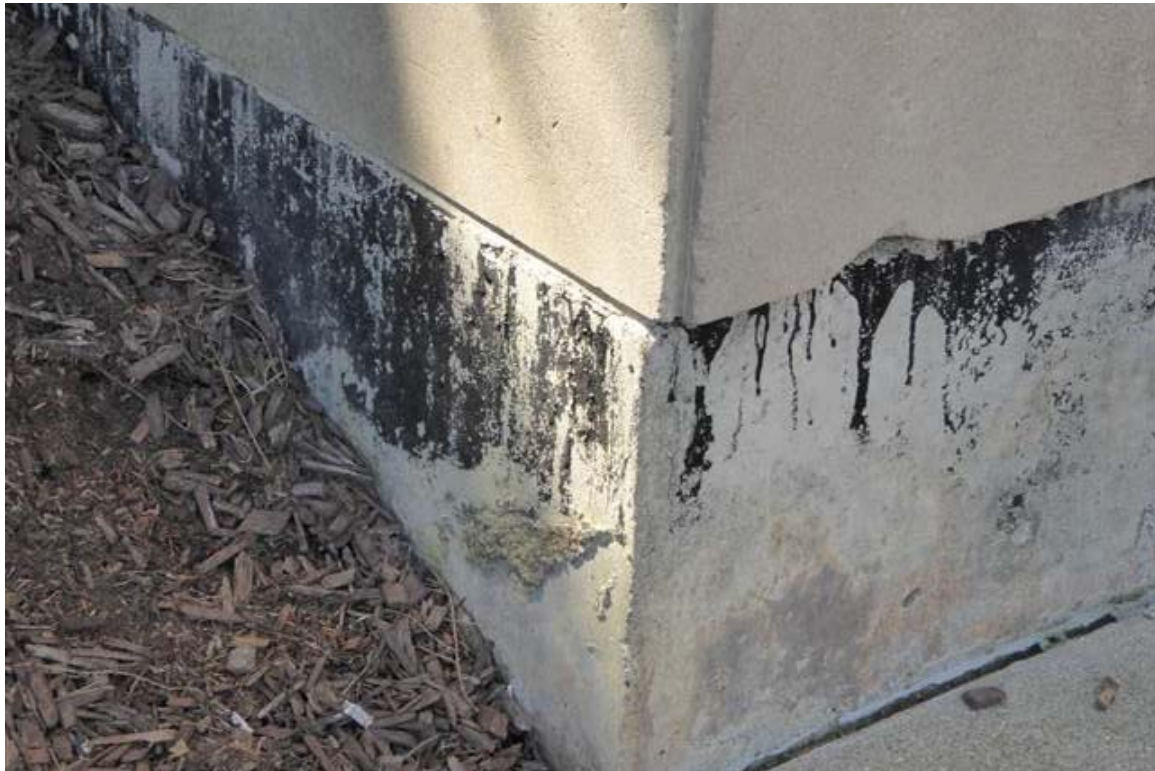
Photo 46 The original bitumen based waterproofing has deteriorated badly.

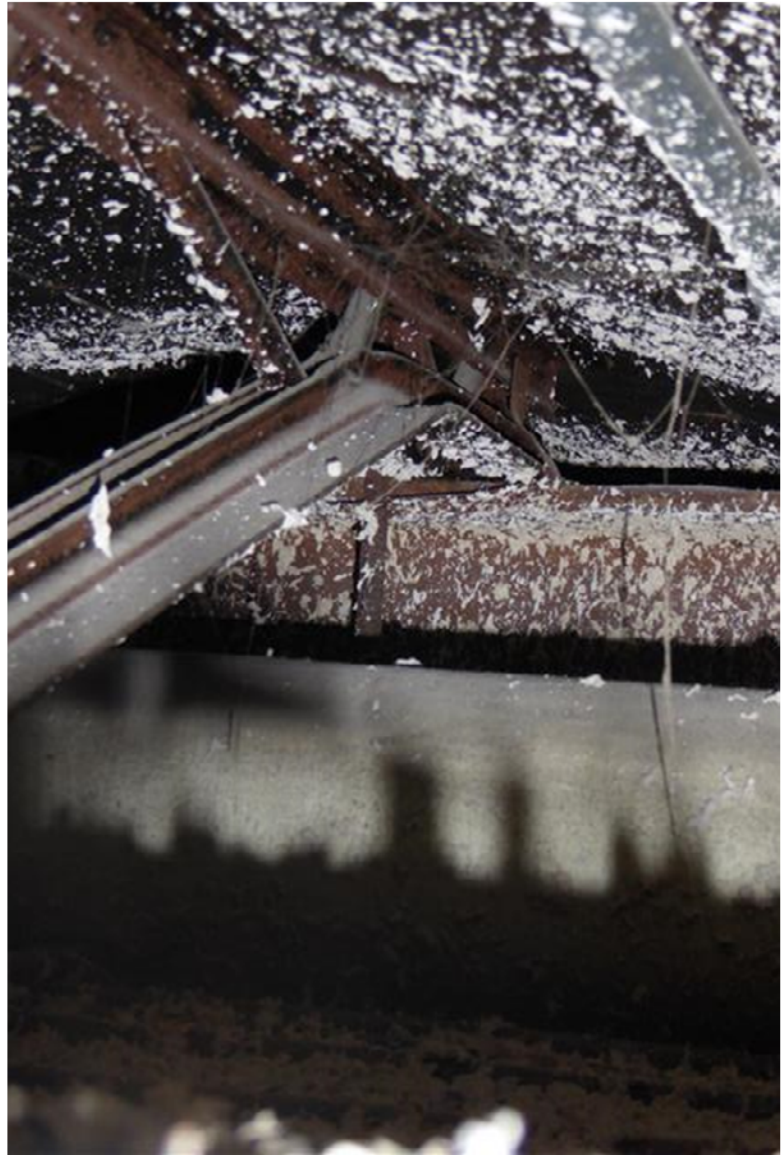
Similar construction was found supporting the second floor slab.

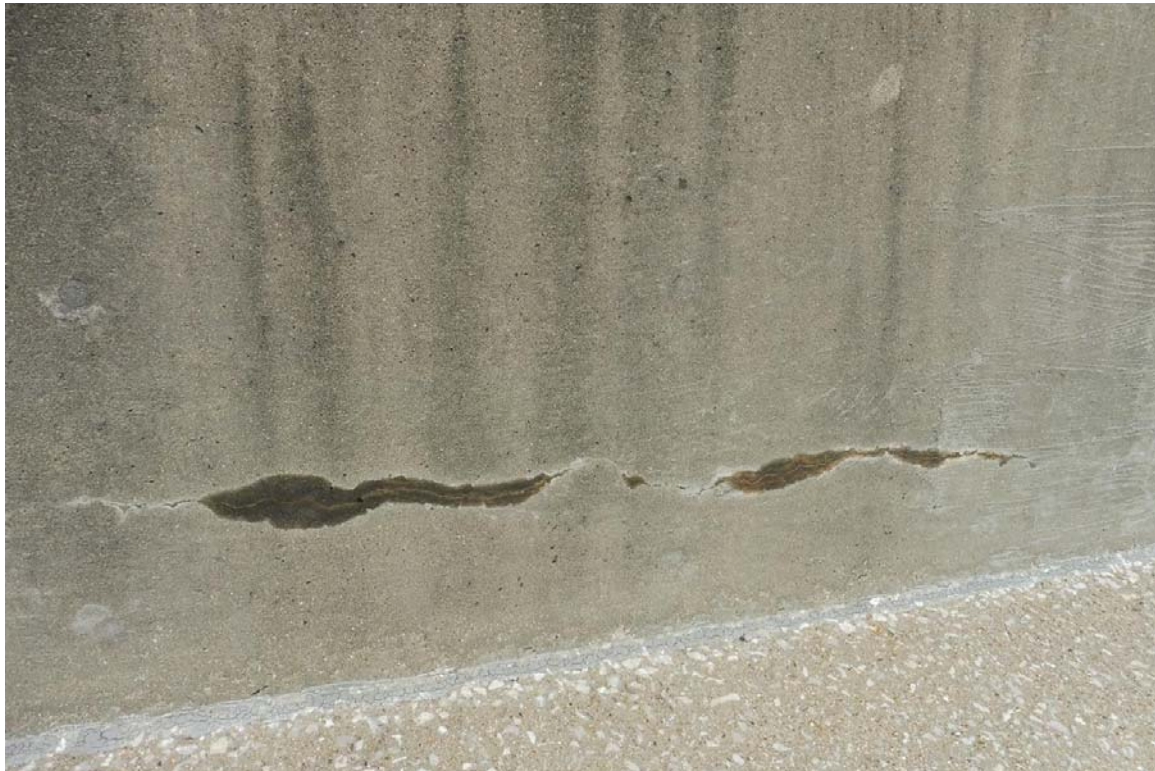
Photo 64 Close-up view of Photo 5.

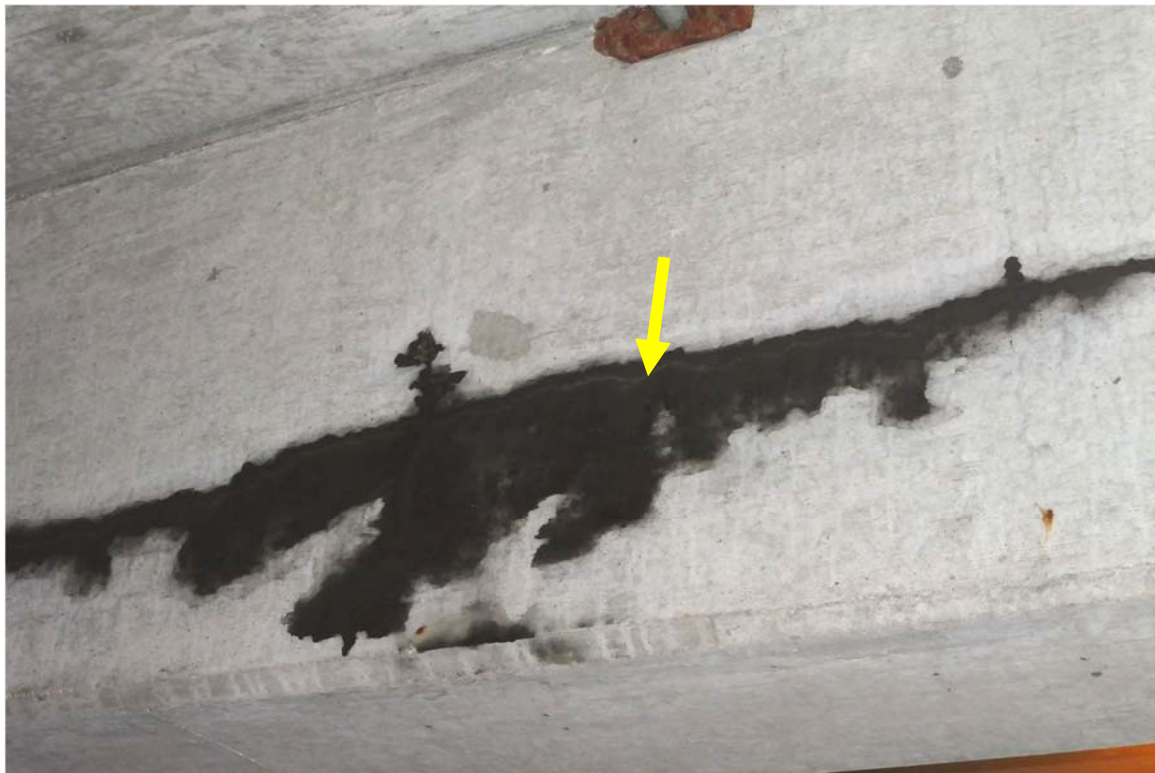
Photo 66 Close-up view of Photo 7. Note the crack seen through the grease staining.

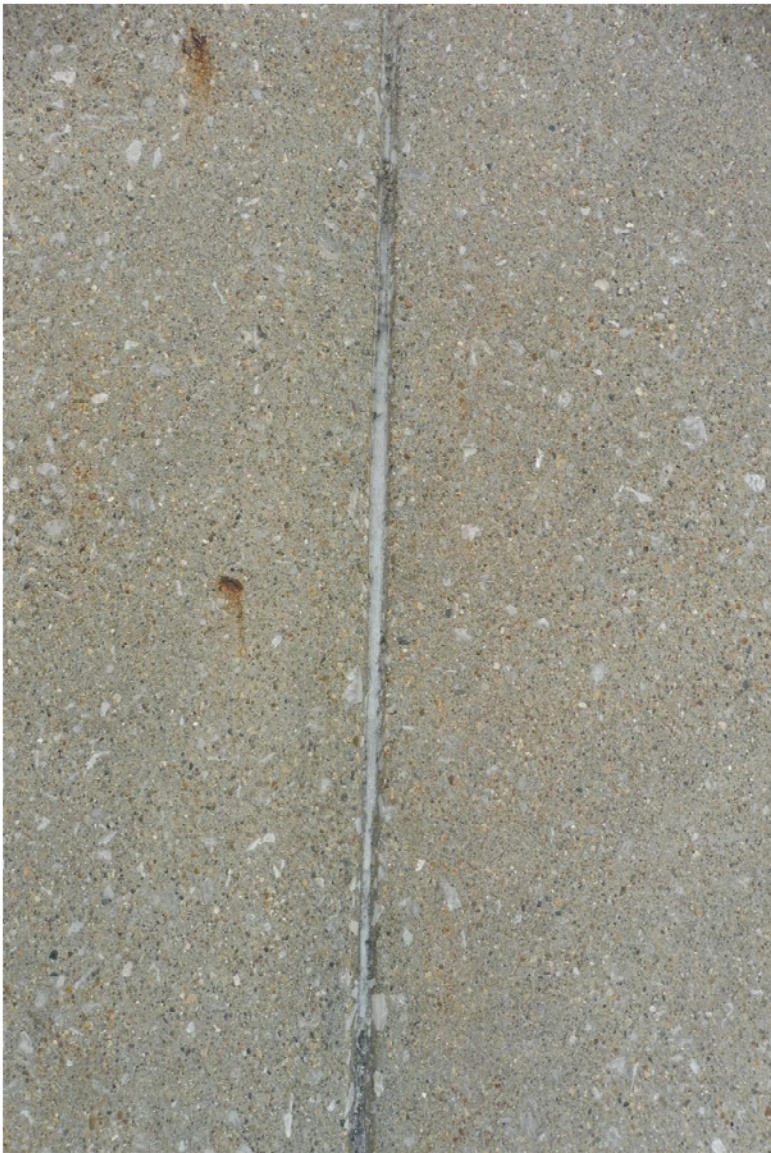
...was observed during the assessment.

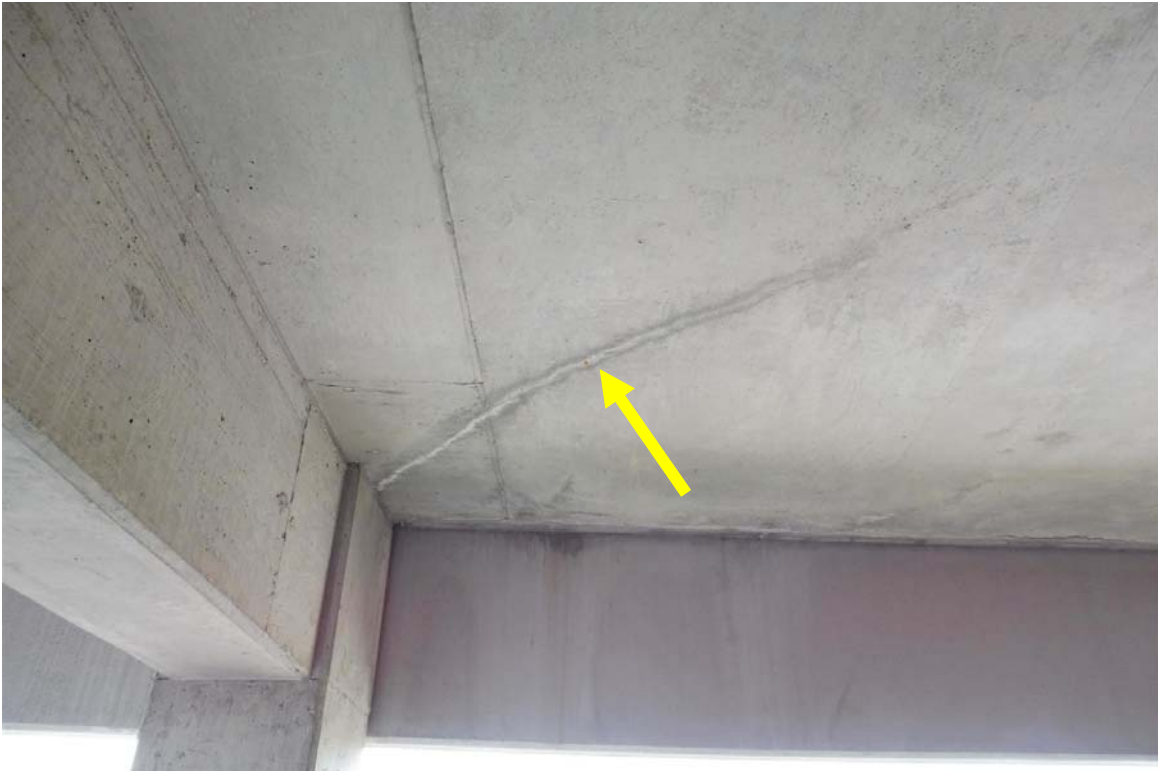
Photo 73 Cracks on the underside of the post-tensioned floor slabs existed in localized areas. The white staining seen along the crack is the result of calcium deposits on the surface from water migration through the crack.

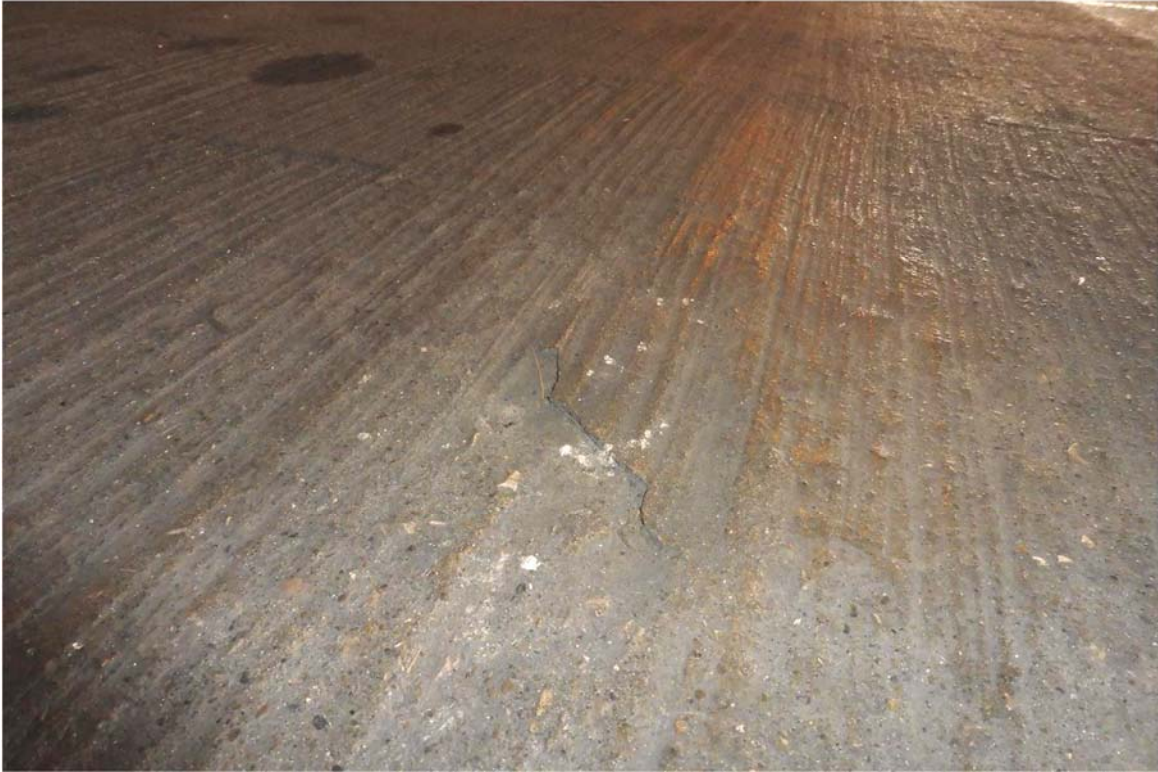
Photo 75 Slab scaling of the top surface was noted at some locations, generally on the lower levels where the volume of vehicles is typically higher.

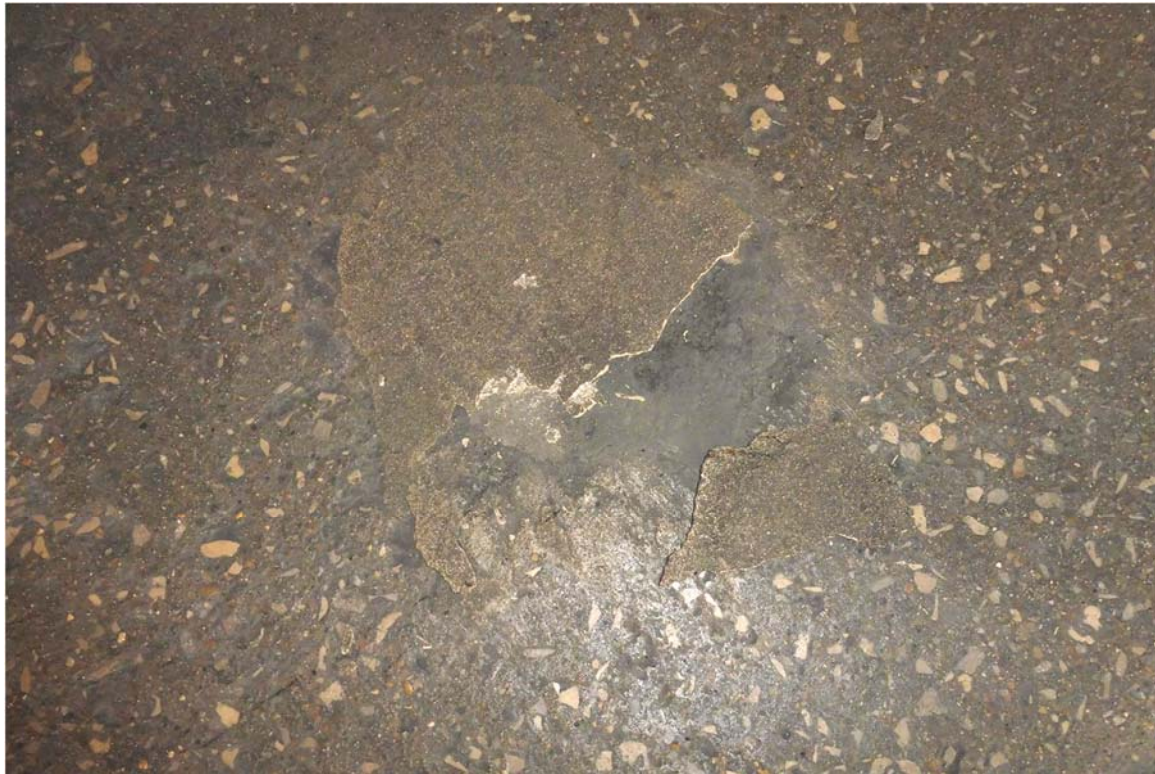
Photo 76 Another example of surface scaling that was observed.

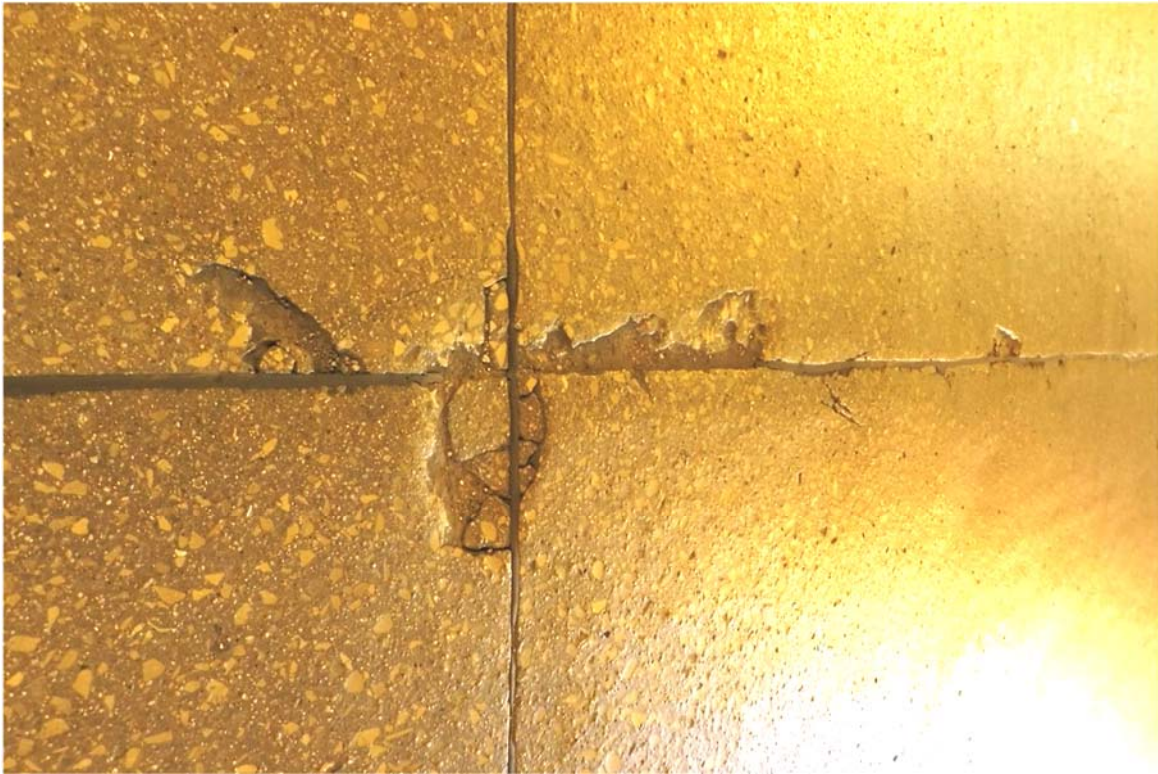
Photo 77 Small spalls in the slab-on-grade at the sawcut control joints should be patched to keep from enlarging with time.

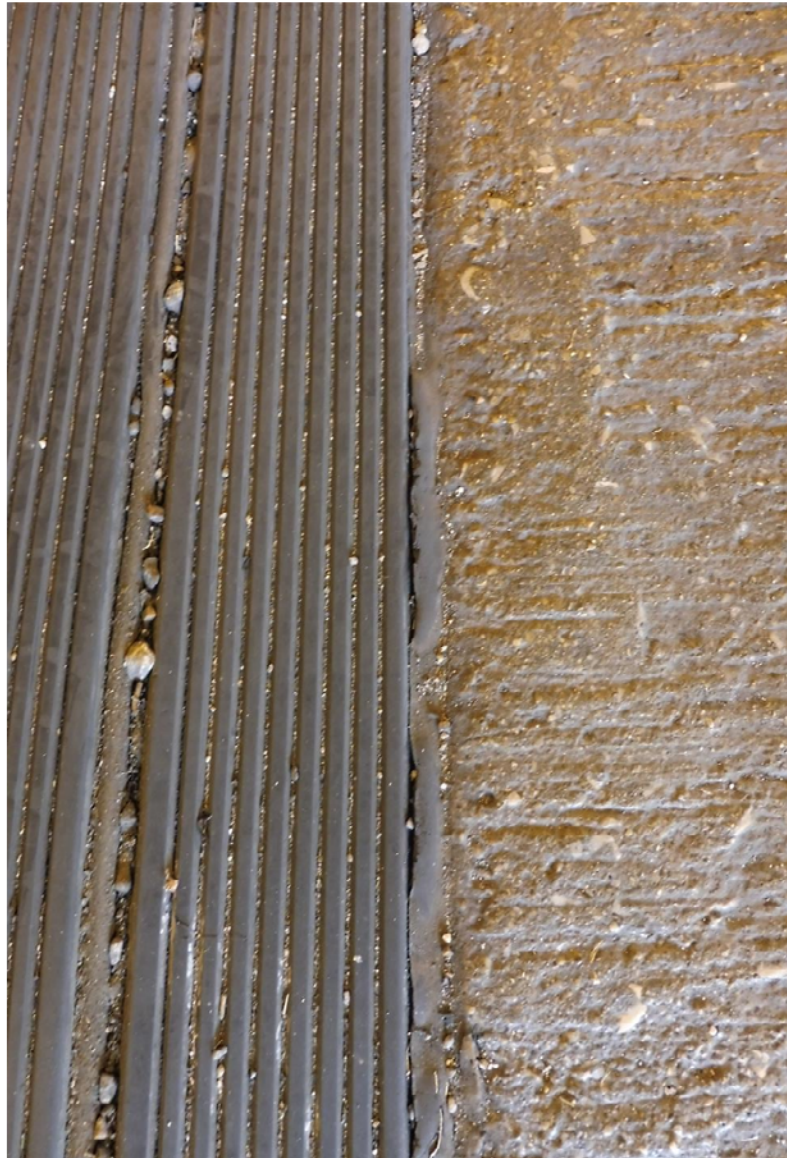
The only expansion joint in the garage exists at the transition between the post-tensioned deck and the slab-on-grade.

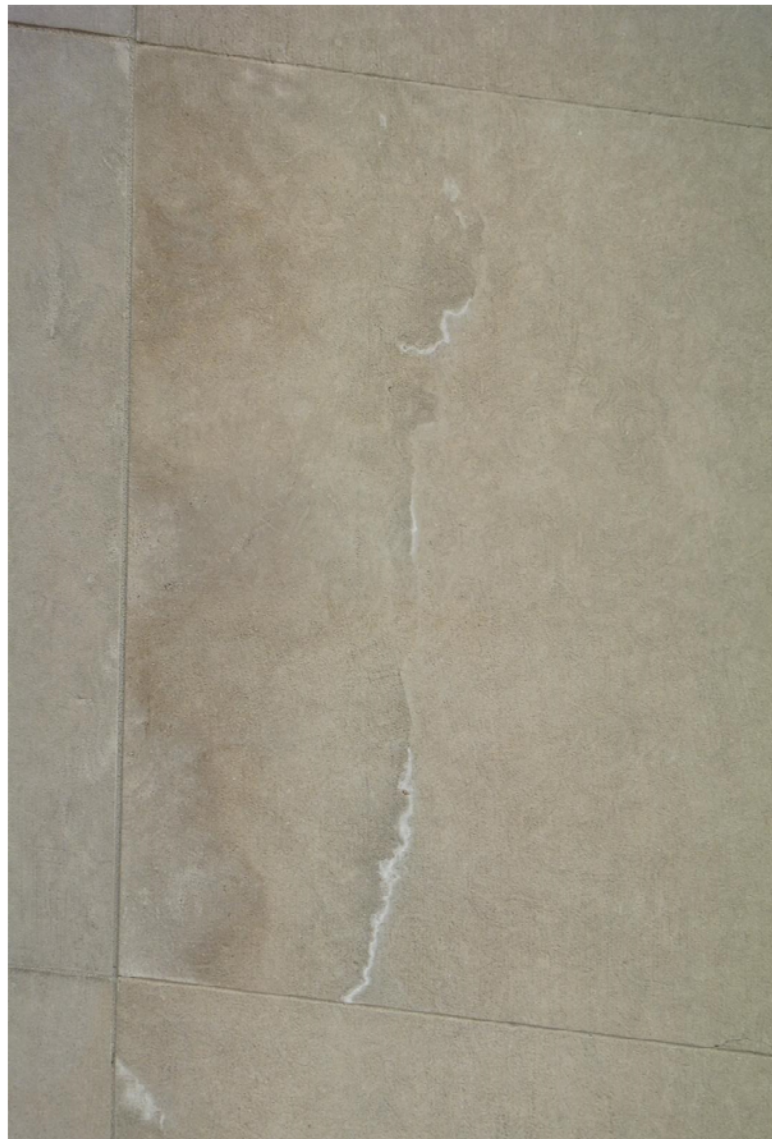
Moisture has migrated through the limestone panel on the stair tower, leaving behind deposits of white staining called efflorescence.

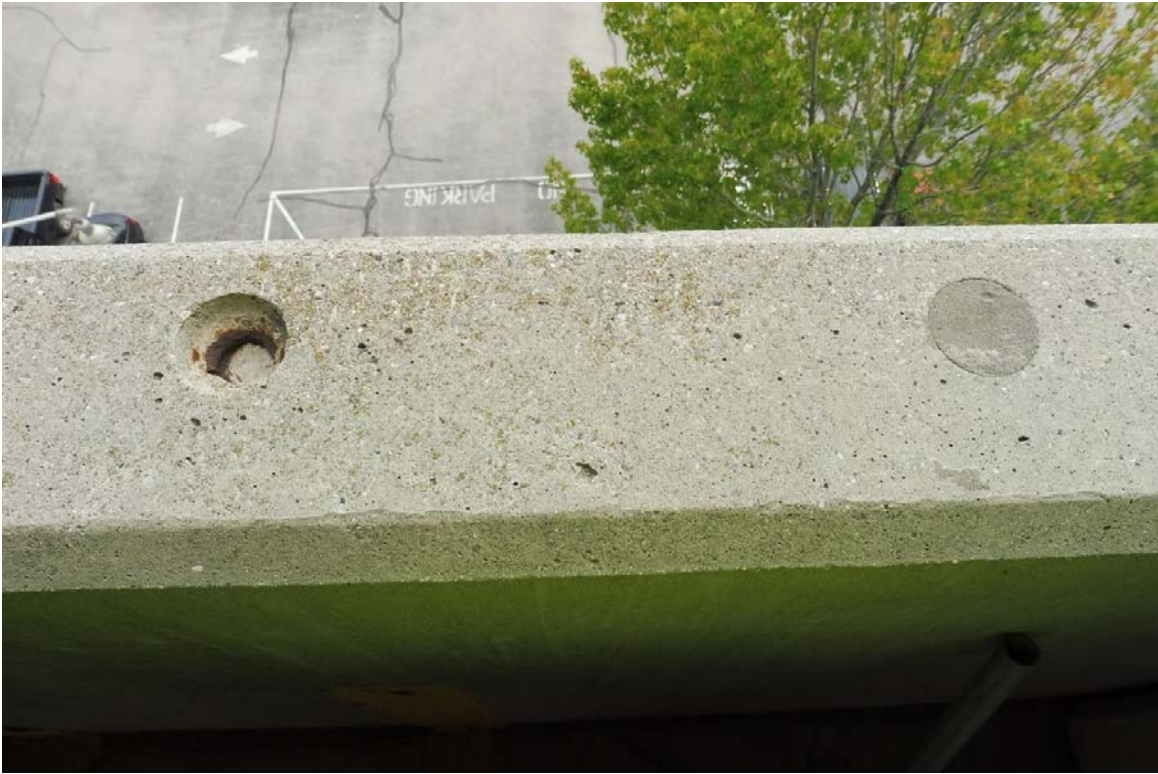
Photo 87 Missing grout pockets at the lift insert holes on the skyward face of the façade panels...

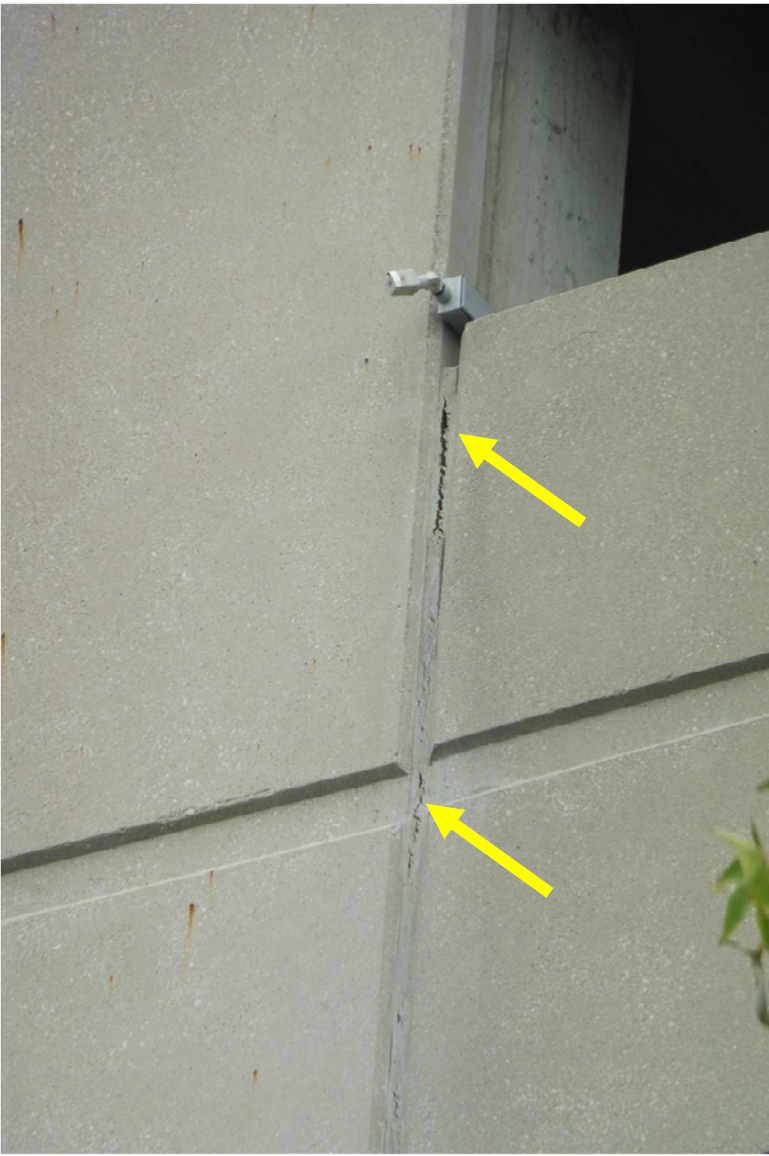
The sealant joints throughout the precast façade...

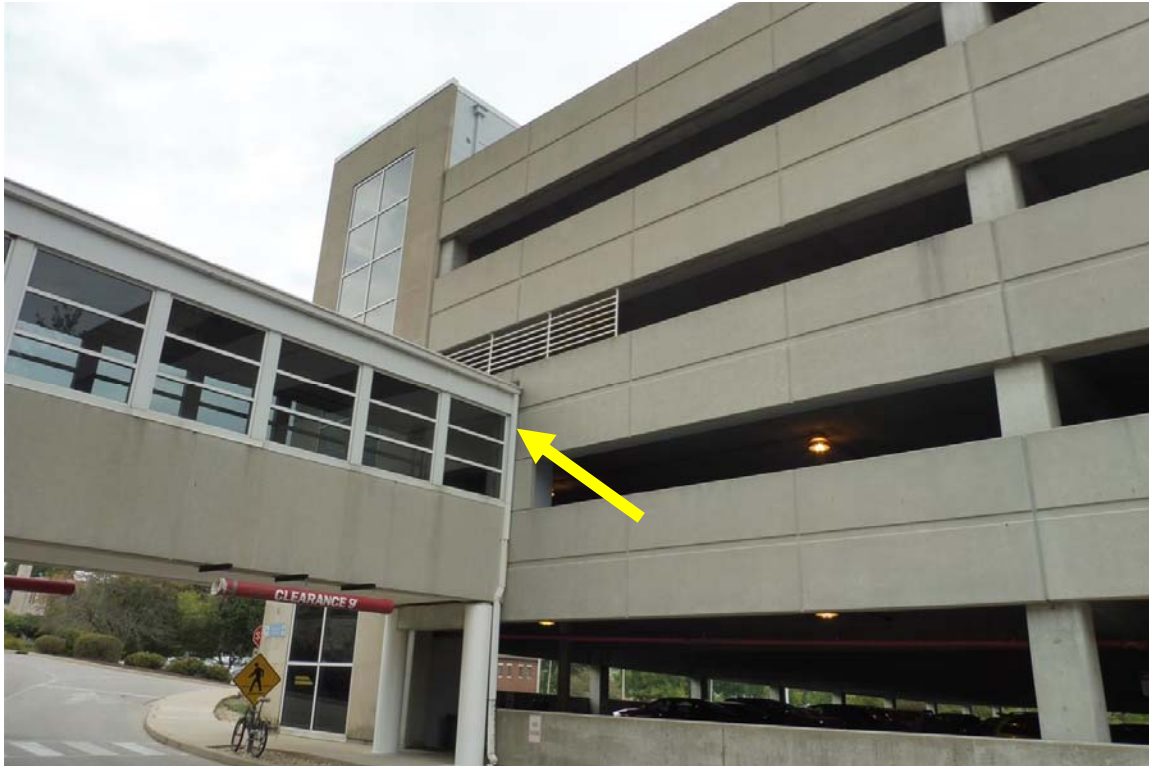
Gaskets in the curtain wall system have shrunk and many have failed. They should be removed and either replaced with new gasket material or wet sealed with liquid sealant.

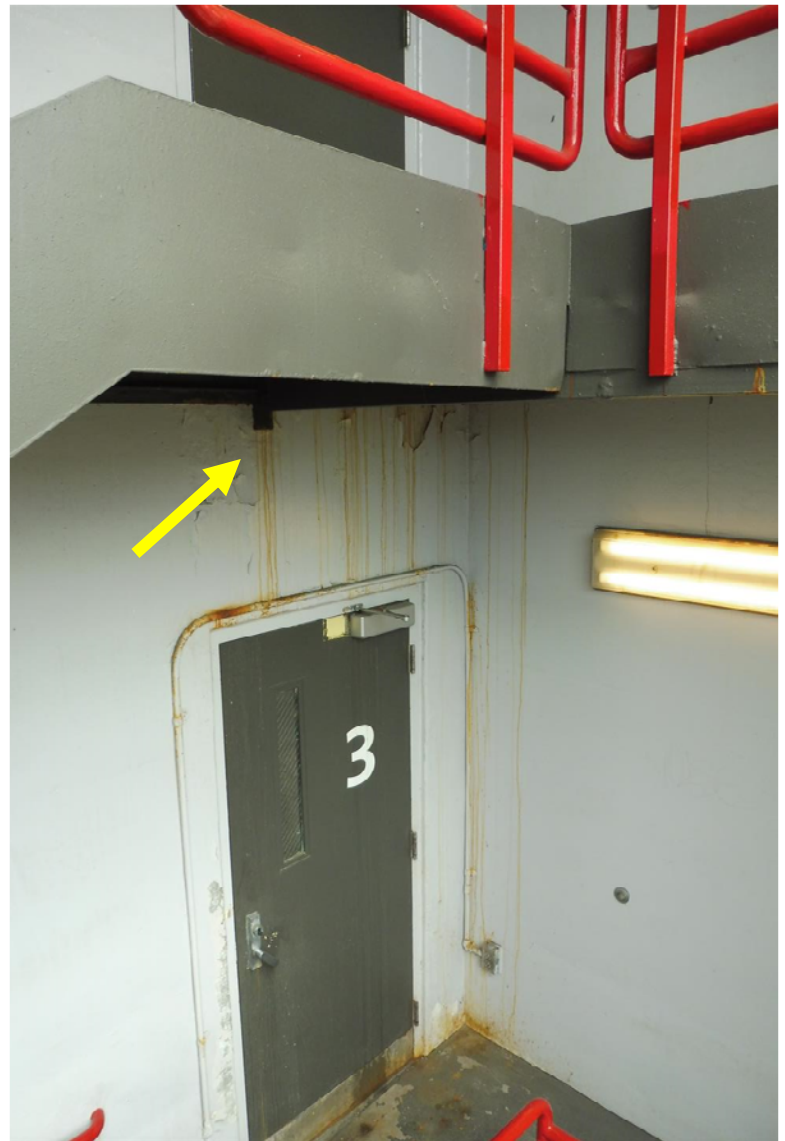
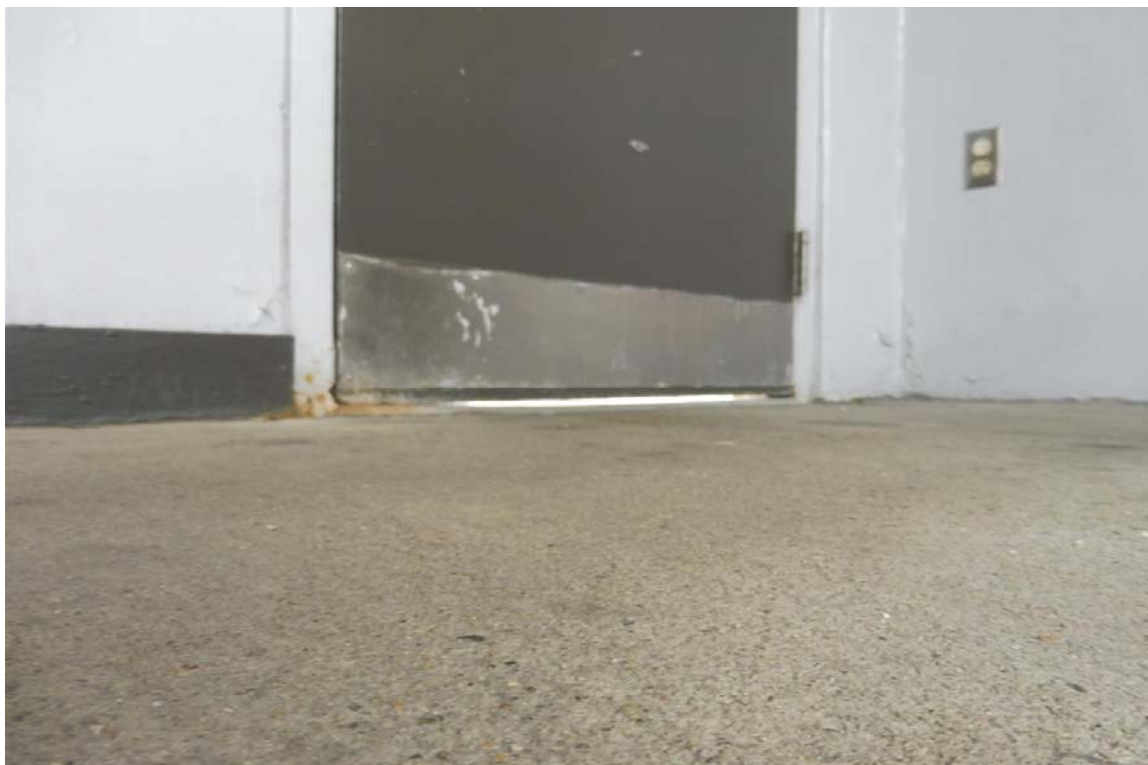
Water infiltration has caused corrosion of the steel stair structure and failure of the coating on the concrete walls inside the stair.

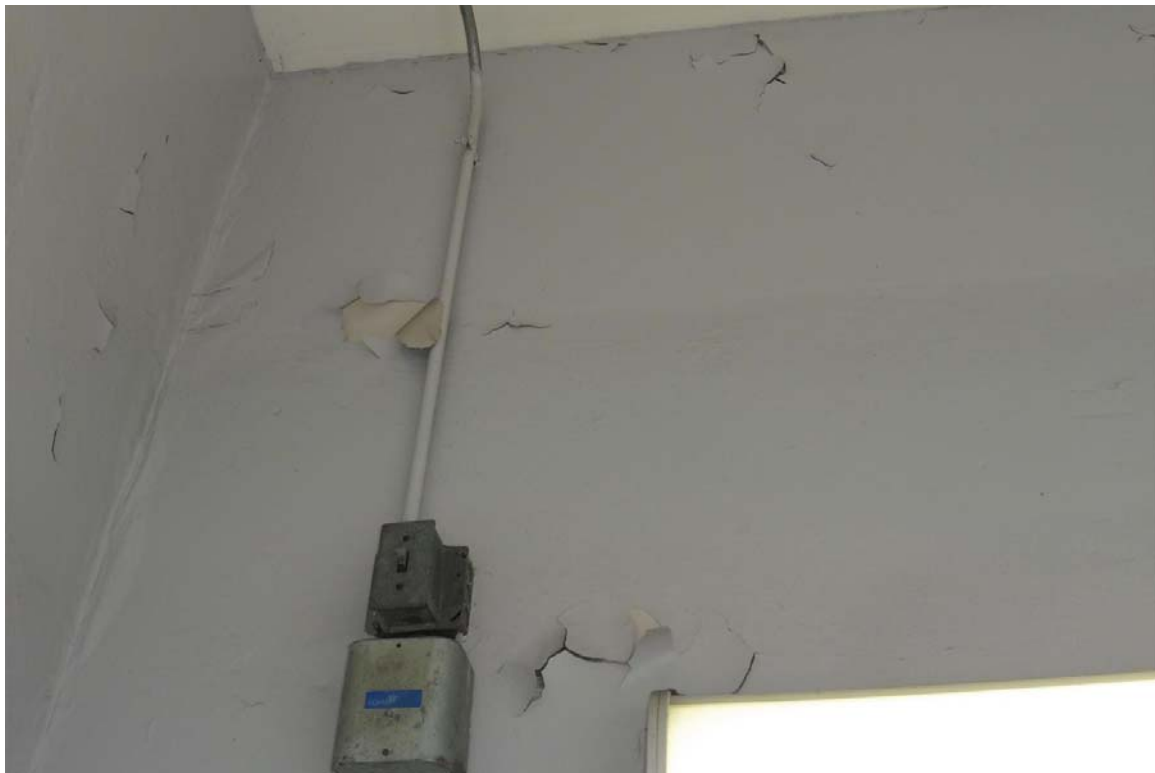
Photo 108 Example of the peeling and failed coating on the concrete walls within the southwest stair.

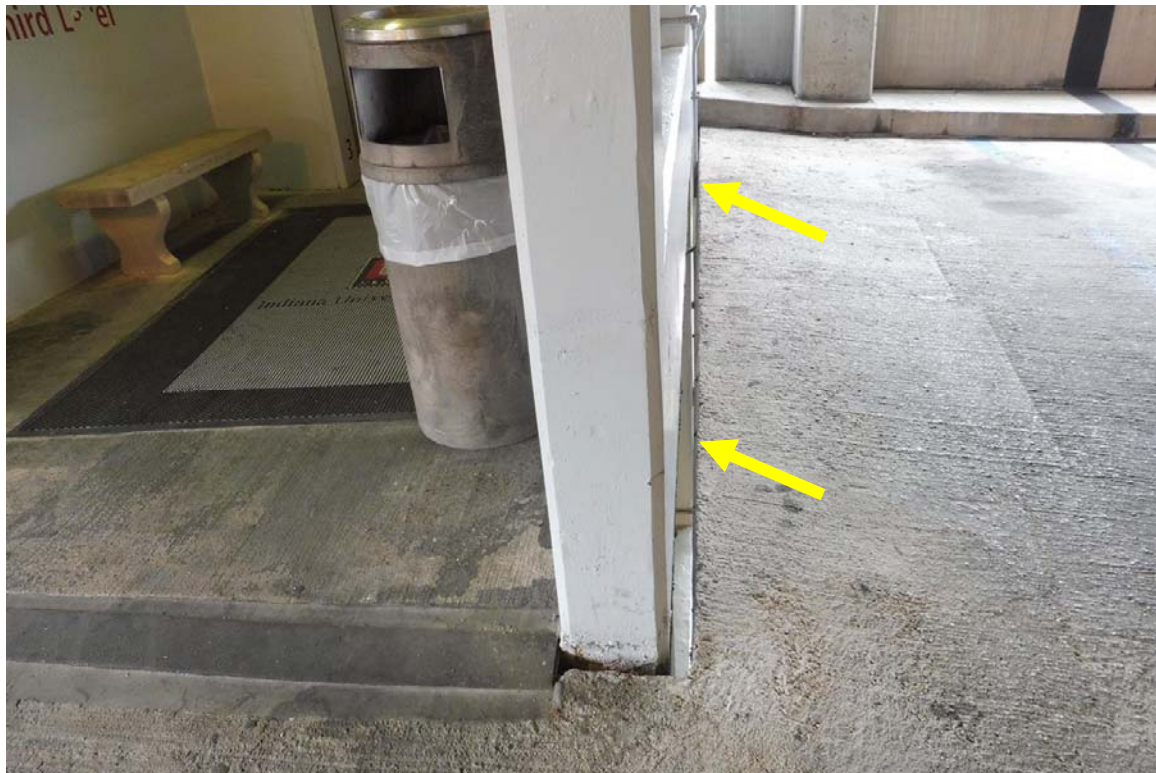
Photo 110 The expansion joint between the southwest stair/elevator tower and the garage floor slab is open at Levels 2 and 3. We would suggest an expansion joint be installed to seal the gap.
