ARSEE ENGINEERS, INC.

CLIENT ORIENTED — BY DESIGN

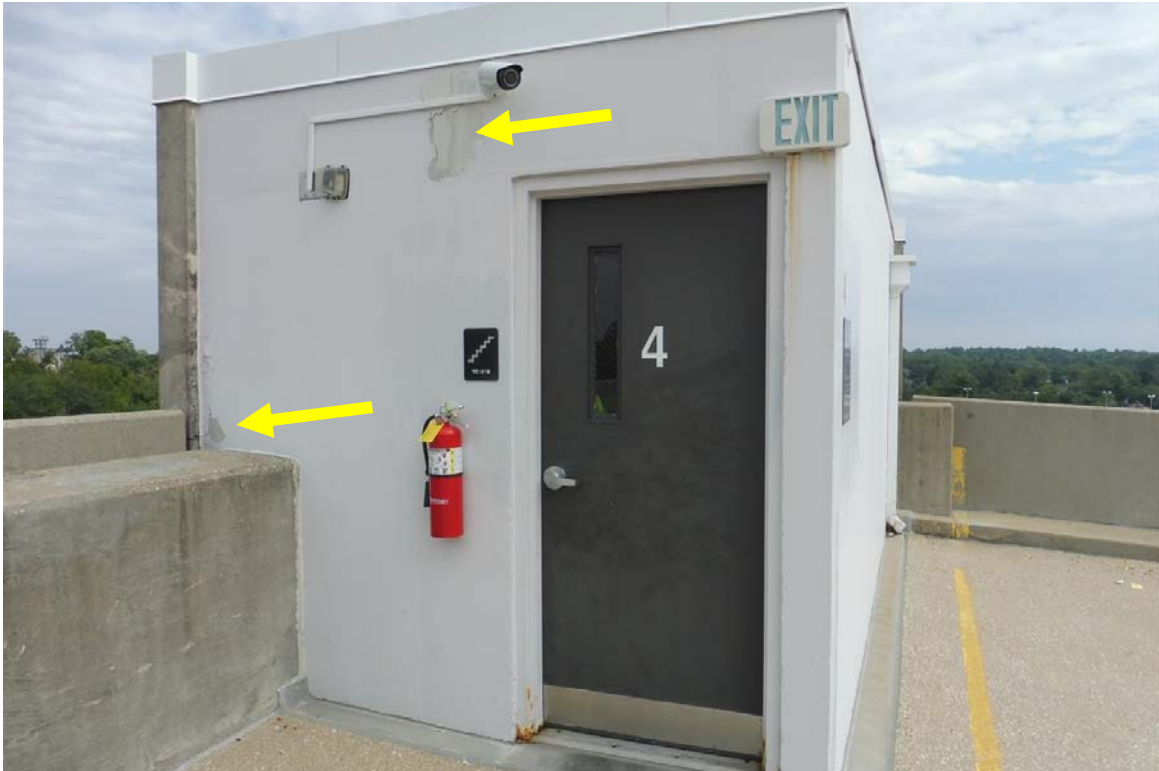
Photo 111 Northeast stair tower at the roof level. The coating on the concrete walls has failed in multiple areas on the outside of the stair tower.

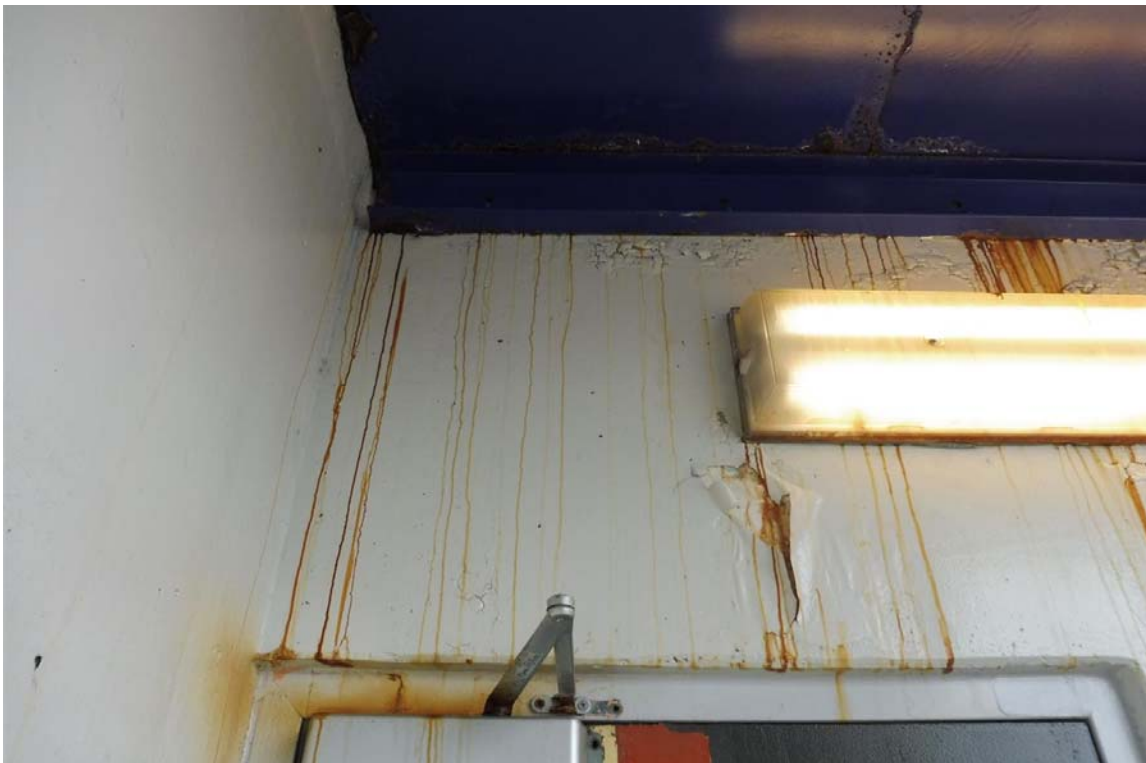
Corrosion of the metal pan stair structure and failure of the wall coatings continued below Level 2.

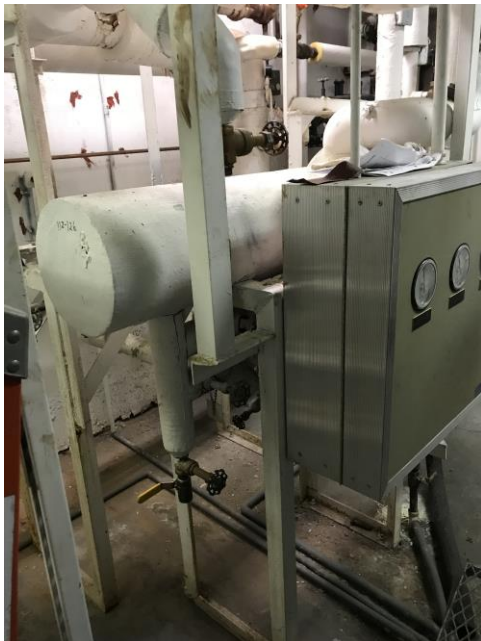
Steam-to-Hot Water Heat exchanger

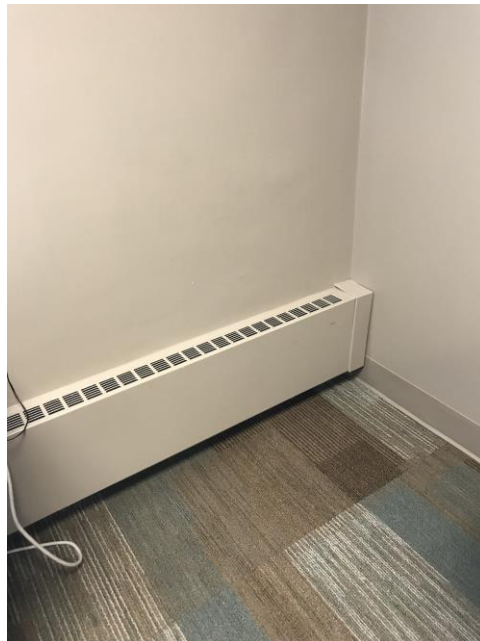
Perimeter hot water heater

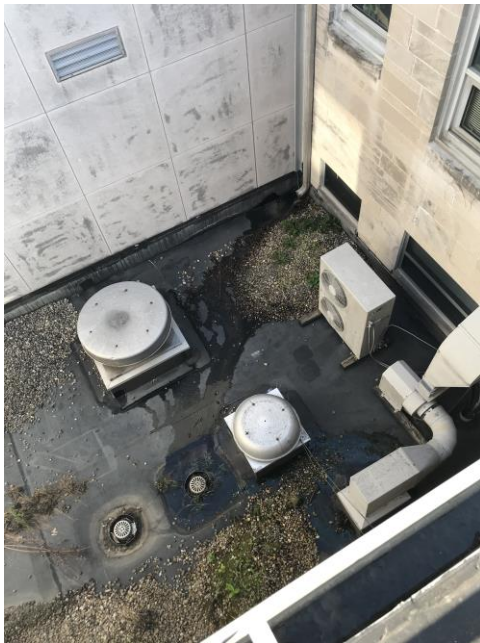
The communications room is served by a dedicated split-system ductless heat pump that was installed in 1982, but which still works.

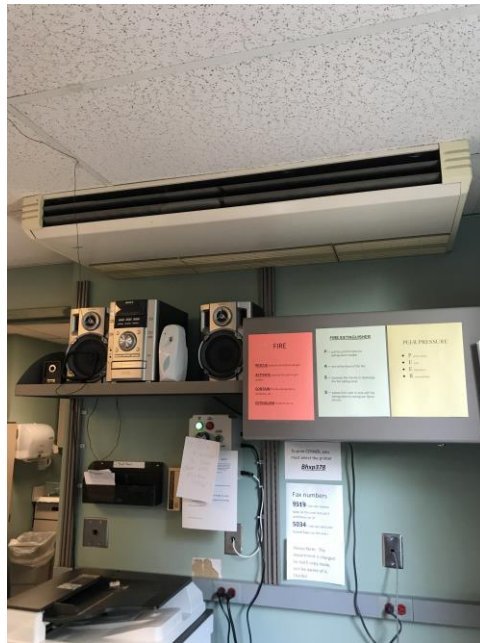
Indoor fan-coil for heat pump

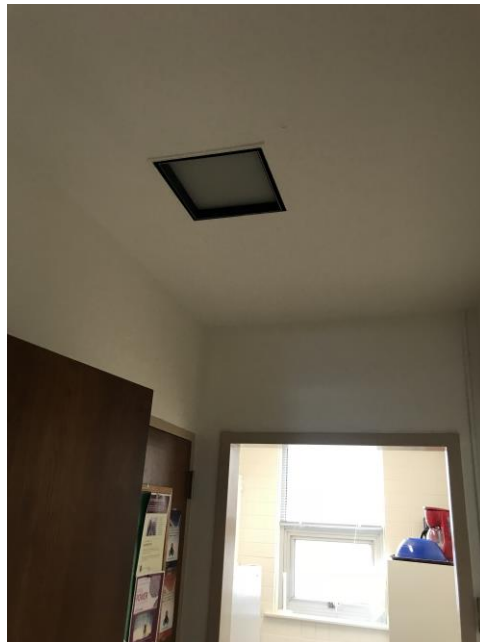
Typical recessed downlight

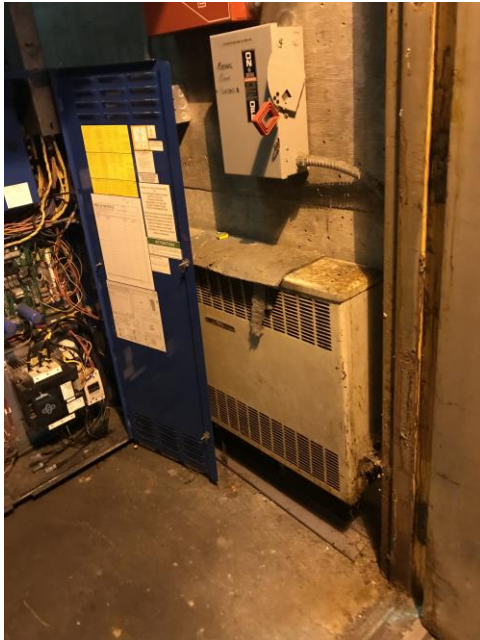
Elevator machine room heater
